Manhole Inspection Summary

Manhole # S39G__020MH

Insp Date: **3/27/08 12:01 PM**

Location Address: **105 s. albemarle st**

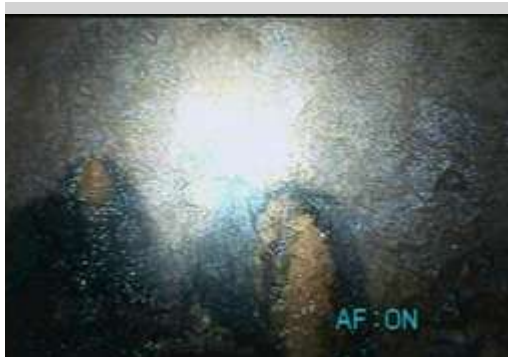
Misc

barrel above pipe at 12

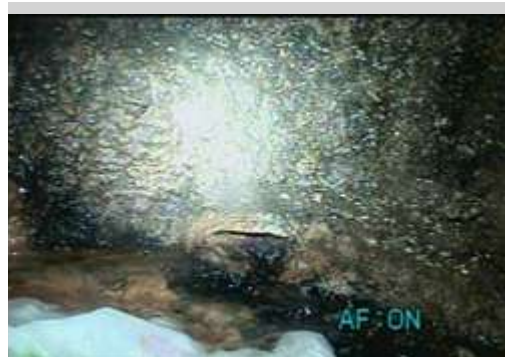
Misc

Comments **There is a hole in the barrel at 3, 18 feet down with water running fast out of it and other holes in the barrel. On the prints they have albemarle st in the wrong place. its the 1st street after s. front st not the 2nd one.**

barrel at 3 18 down 2nd view

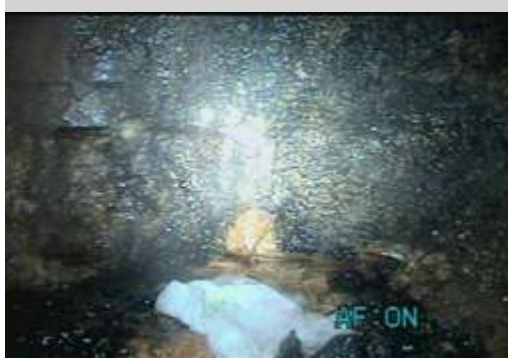
Defect 9

Condition: ☐ Sound ☐ Cracked ☐ Root Intrusion ☐ Loose Brick ☒ **Deteriorated**

Infiltration: ☐ None ☒ **Joint** ☐ Cracks ☐ Mortar ☐ Roots ☒ **Wall**

hole in barrel 18 down with water flowing fast out of it at 3

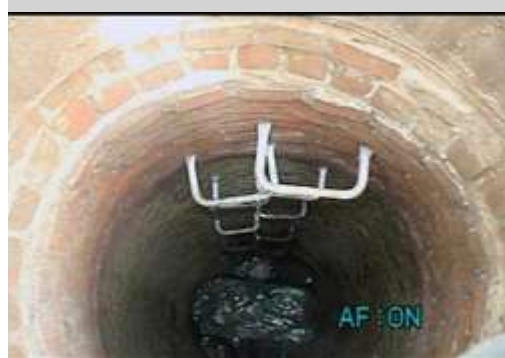
Defect 2

Count: **12** Missing: **0** ☒ **Corroded**

steps

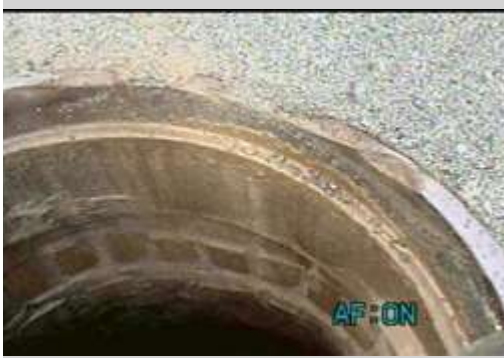
Defect 1

Condition: ☐ Sound ☒ **Cracked** ☐ Leaks

crack_frame missing part of frame

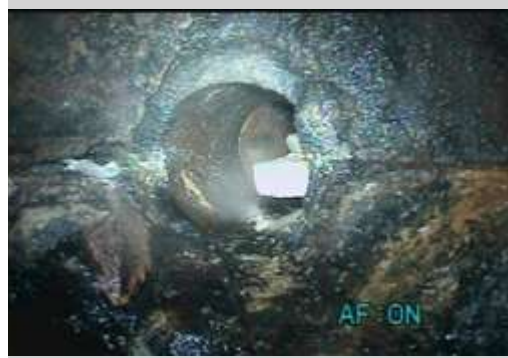
Defect 8

Condition: ☐ Sound ☐ Cracked ☐ Root Intrusion ☐ Deteriorated ☐ Leaks ☒ **Debris**

channel debris

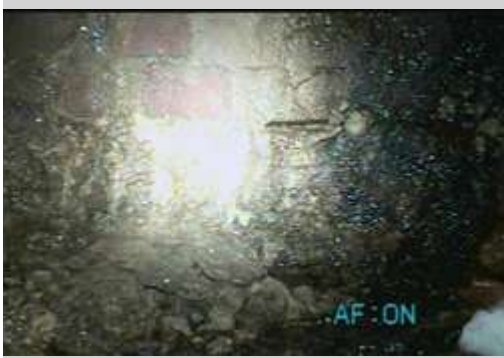
Defect 6

Condition: ☐ Sound ☐ Cracked ☐ Root Intrusion ☐ Deteriorated ☐ Leaks ☒ **Debris**

bench debris

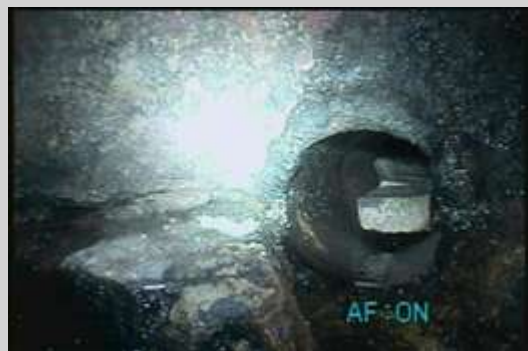
9 O'Clock Inflow

Deposits: ☐ None ☐ Mud ☐ Sludge ☒ **Debris** ☐ Grease

Silt Depth: **4** (in.) Deposits Extent: **Medium**
